RESPONSE TO RESTORATION: WATER TEMPERATURE CONDITIONS IN BIG SPRINGS CREEK AND SURROUNDING WATERWAYS, 2009-2011

A Report for The Nature Conservancy

Prepared By
Ann Willis
Mike Deas

September, 2012

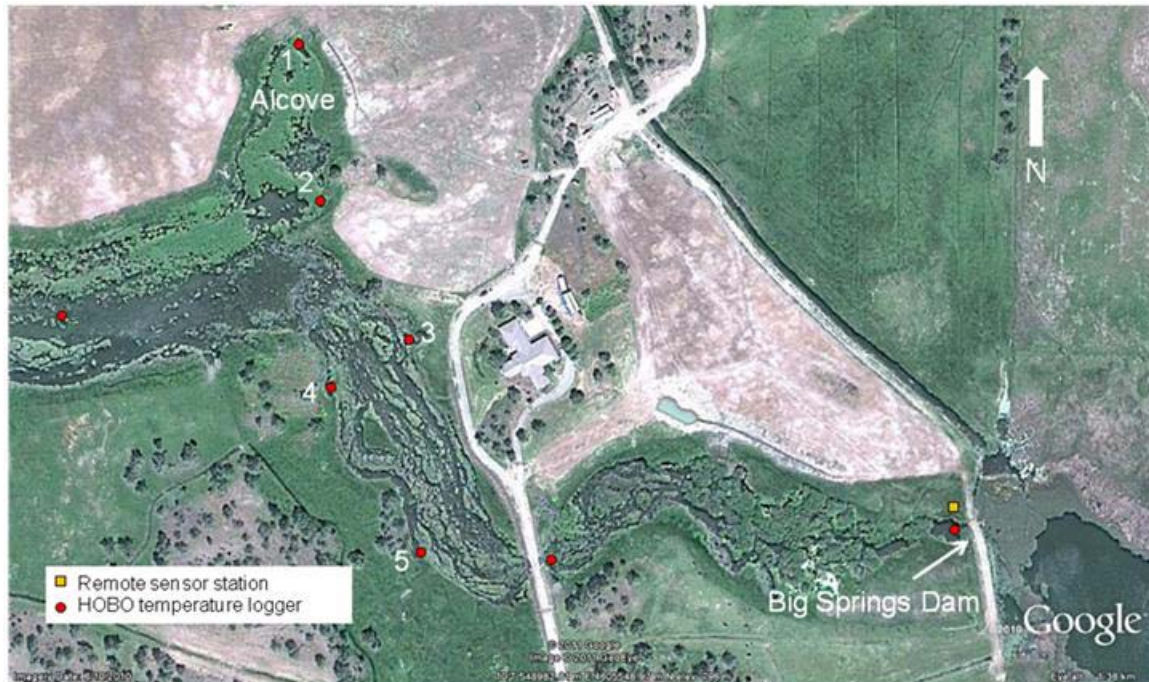
Figure 5. A map of the groundwater-fed spring monitoring sites, as well as other mainstem monitoring sites, in Big Springs Creek. Groundwater-fed spring monitoring sites are numbered 1 to 5.

Groundwater-fed springs were the primary source of cool (10 to 12°C) water in Big Springs Creek. Springs were generally located in the 0.6 km (0.4 mi) reach below Big Springs Dam and were located both in the channel and on the channel margins. To generally characterize the water temperature of the springs, data loggers were placed in five locations where discrete spring inflows were observed (Figure 5). These locations were named:

1. North alcove spring,
2. East alcove spring,
3. Below Busk house bridge, river right (RR),
4. Below Big Springs island, river left (RL), and
5. Below Busk house bridge, RL.

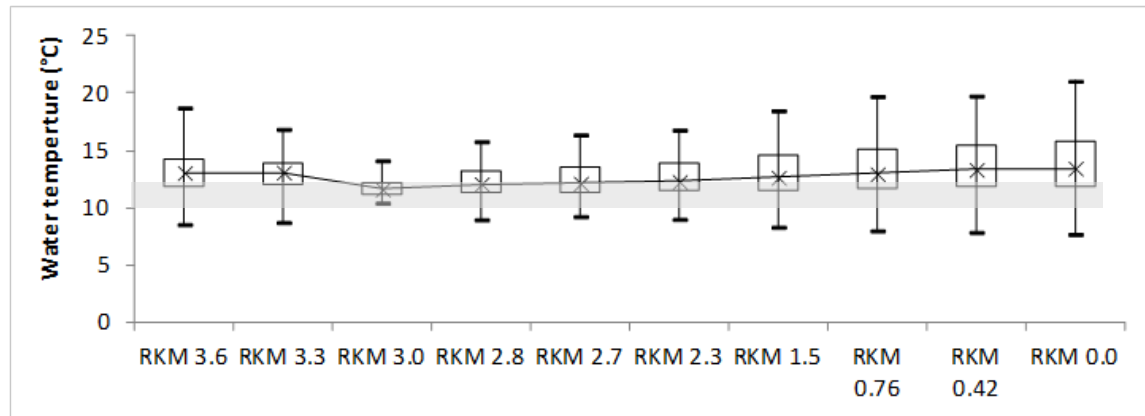
The water emanating from the discrete spring sources had the greatest effect on water temperatures in Big Springs Creek. A box-plot analysis of water temperatures at monitoring locations from Big Springs Dam (river kilometer (RK) 3.6/river mile (RM) 2.2) to the mouth (RKM 0.0/RM 0.0) illustrates that the springs, and not inflows from Big Springs Dam, defined the creek's thermal regime (Figure 7). Although inflow water temperatures from Big Springs Dam generally contributed water warmer than 12°C, water temperatures in Big Springs Creek were generally cooler and showed substantially less variation at RKM 3.0 (RM 1.9), the monitoring site located downstream of the extensive discrete spring sources. The range of water temperatures measured at RKM 3.0 (RM 1.9) during the 2011 field season (April to September) were consistent with those measured in the discrete spring sources, indicating that the springs sources act to "reset" whatever thermal conditions that were inherited from upstream.

Figure 7. A box-and-whisker quartile plot of water temperatures from April 1-September 30, 2011 in Big Springs Creek from Big Springs Dam (RKM 3.6/RM 2.2) to the mouth (RKM 0.0/RM 0.0). The line plots the median water temperature at each monitoring location, while the box represents the upper and lower quartile range. The whiskers and dashes illustrate the absolute maximum and minimum water temperatures for each location. The grey band illustrates water temperatures between 10 to 12°C for reference purposes.

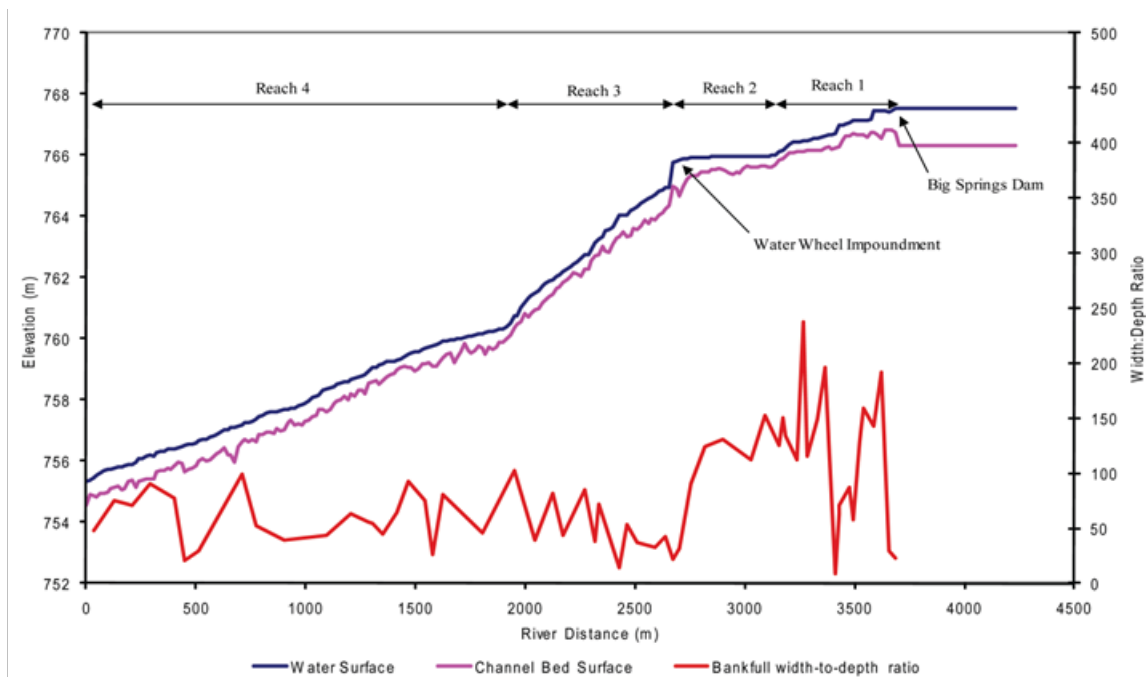
Figure 8. The elevation profile of the channel bed and water surface in Big Springs Creek, as well as width:depth. Figure provided by Andrew Nichols (U.C. Davis Center for Watershed Sciences).

There are also four distinct reaches where different slopes are observed. Reach 1 begins at Big Springs Dam (RKM 3.6/RM 2.2) and ends where the alcove meets Big Spring Creek (RKM 3.3/RM 2.0). The slope in this reach is moderate ($S=0.003$). Reach 2 begins at RKM 3.3 (RM 2.0) and ends at the waterwheel (RKM 2.7/RM 1.7). This is the least steep reach ($S=0.0003$). Reach 3 begins at RKM 2.7 (RM 1.7) and ends at RKM 1.9 (RM 1.2), upstream of the tail water return point from the pond on the north side of the creek. Reach 3; is the steepest in the creek ($S=0.006$). Finally, the slope returns to a moderate gradient in Reach 4 ($S=0.003$), which begins at RKM 1.9 (RM 1.2) and ends at the mouth of Big Springs Creek (RKM 0.0/RM 0.0).

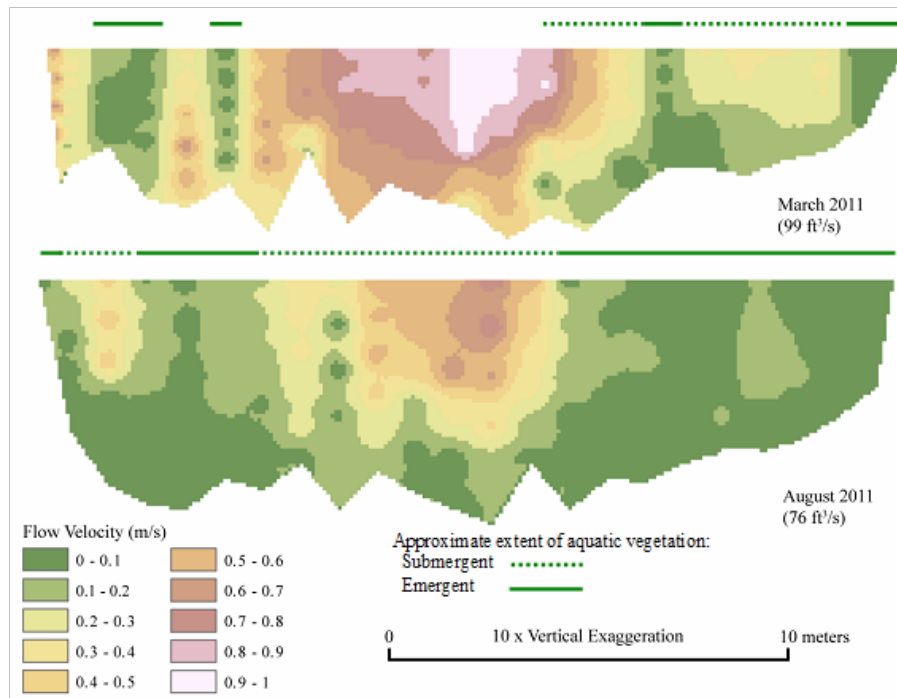
Figure 11. Flow-velocity contour plots created from point velocity measurements collected at RM 0.3 in Big Springs Creek. Approximate locations of submerged and emergent vegetation are illustrated. Figure taken from Willis *et al.* (2012).

Early season surveys showed that stream flow was concentrated into open portions of the stream channel. These areas were characterized by higher velocities (0.2 m/s to 1.0 m/s) than areas where vegetation was present (less than 0.1 m/s). Mean velocities generally decreased as aquatic vegetation density and distribution increased. Later season surveys showed that stream flow velocities had generally decreased throughout the channel and submergent and emergent vegetation was also present throughout.

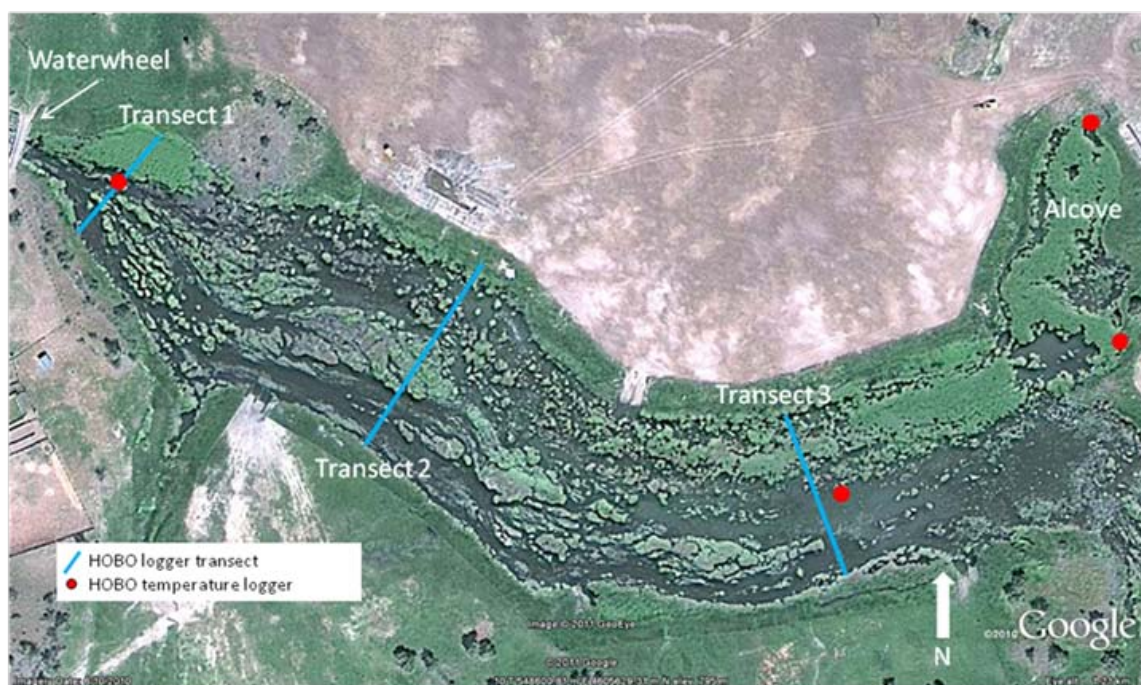
Figure 17. Water temperature monitoring transects in the football field. The transects were established as part of a short-term special study. Other locations were monitored as part of the previously established, long-term water temperature monitoring program.

Three water temperature monitoring transects were established in the football field to monitor the lateral and longitudinal trends between August 2010 and October 2011 (Figure 17). Each transect consisted of five temperature loggers placed approximately 15 m (50 ft), 30 m (100 ft), 45 m (150 ft), 61 m (200 ft), and 76 m (250 ft) from the north (or river right) bank (“river left” and “river right” always describe a location relative to the downstream view of a waterway). These water temperature monitoring transects were maintained in addition to previously established, long-term water temperature monitoring locations.

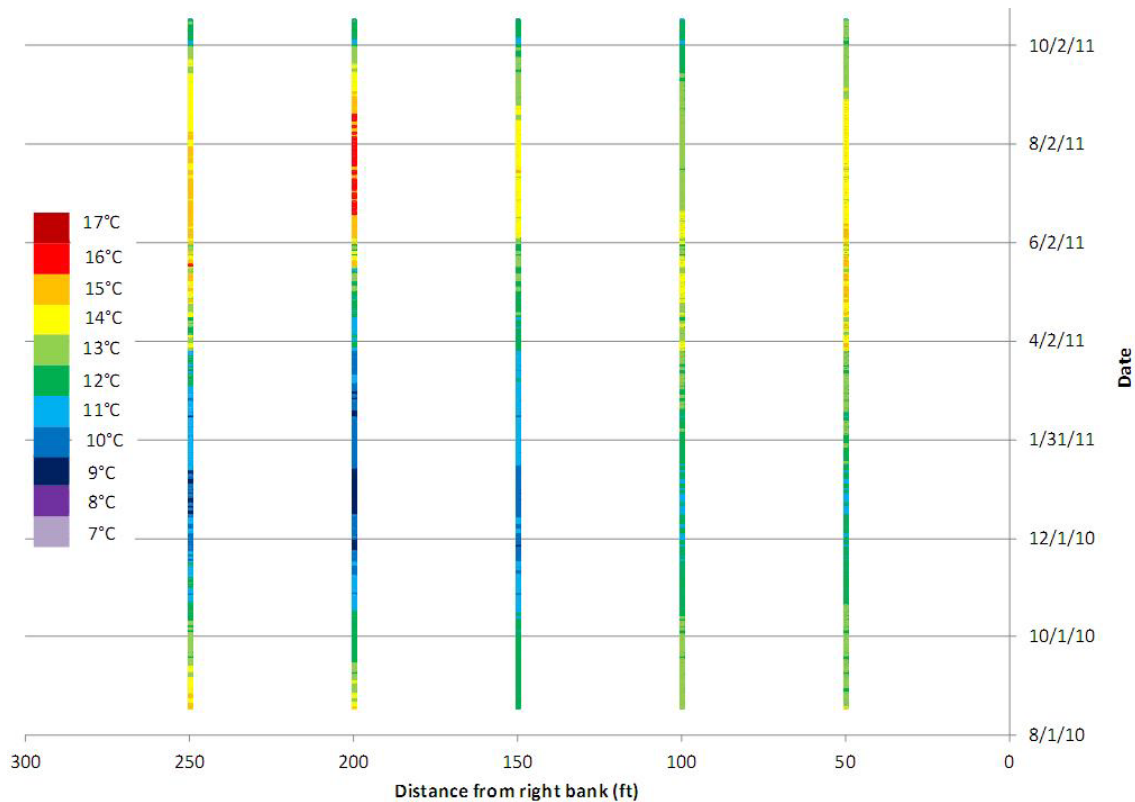
Figure 18. Water temperatures at each monitoring site in Transect 3 from August 2010 to October 2011.

Data collected from each transect was plotted to examine maximum water temperature characteristics over the special study period (e.g., Transect 3 in Figure 18). While the images taken in 2008 show a diurnal shift between laterally well-mixed and laterally stratified water temperature conditions, the data collected in 2011 also illustrate a seasonal shift in the extent of mixing or stratification. In October 2010, maximum water temperatures across the transect generally ranged between 12°C and 13°C, with no substantial water temperature difference between monitoring sites. By January 2011, some lateral stratification was apparent, with cooler water temperatures (9°C to 10°C) observed on river left and warmer water temperatures (12°C to 13°C) on river right. This lateral pattern continued through the summer, with the difference between maximum water temperature increasing and the location of warmer and cooler waters shifting. In August 2011, maximum water temperatures ranged from 13°C to 17°C across the transect. The relative position of warmer and cooler waters also shifted, with the warmest temperatures located on river left and cooler water temperatures located on river right. Similar dynamics occurred in Transects 1 and 2.

may have restricted and directed stream flow from the springs through the vegetated areas while also providing shade to reduce heating as spring water moved downstream. When the aquatic vegetation senesced in the fall, water from the various springs could more easily coningle with waters across the transect. The free exchange of waters across the transect, combined with the reduced heating that occurs in late fall, resulted in almost fully mixed conditions across the transect again in October 2011.

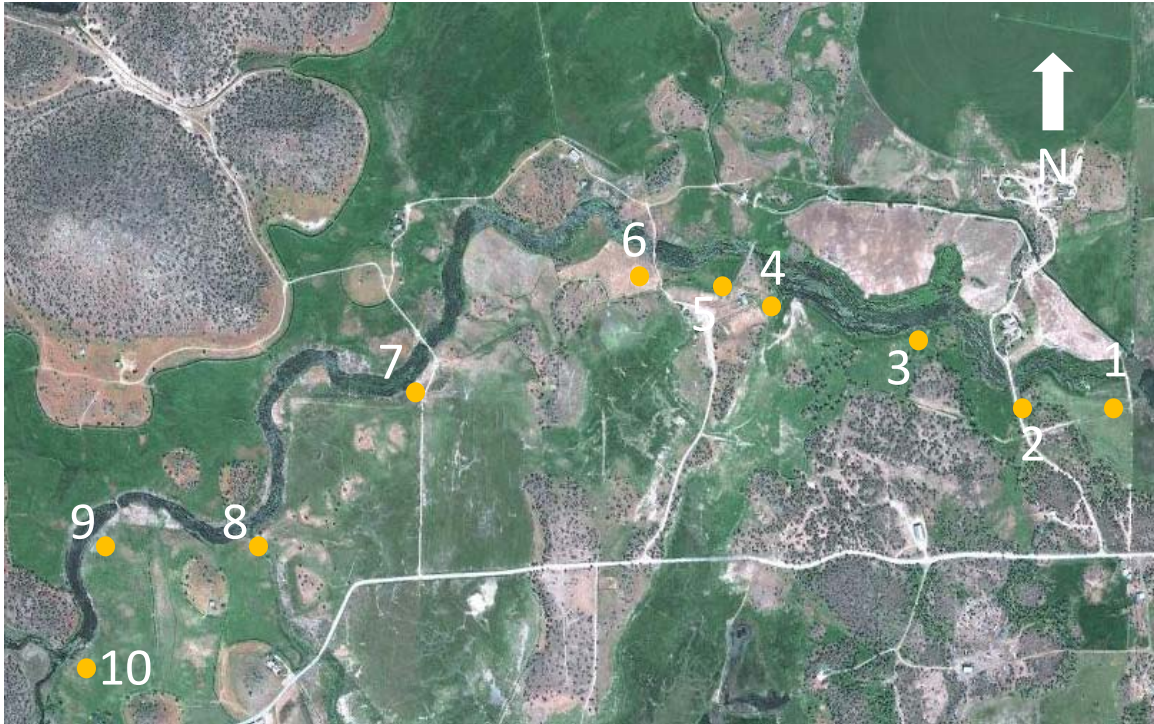
Figure A-3. A map of the sites at which TBSM results were compared to measured water temperature data.

After each update was incorporated into TBSM, model performance greatly improved, particularly its representation of peak water temperatures. Model performance was determined by comparing how closely TBSM simulated water temperatures that represented observed conditions in both space and time. Ten locations were selected throughout Big Springs Creek at which simulated water temperatures were compared to observed water temperatures (Figure A-3). The comparison consisted of examining the mean bias, mean absolute error (MAE), and root mean square error (RMSE) of the results.
