Denier Restoration Biophysical Monitoring

Center for Watershed Sciences, UC Davis

2014 Annual Report

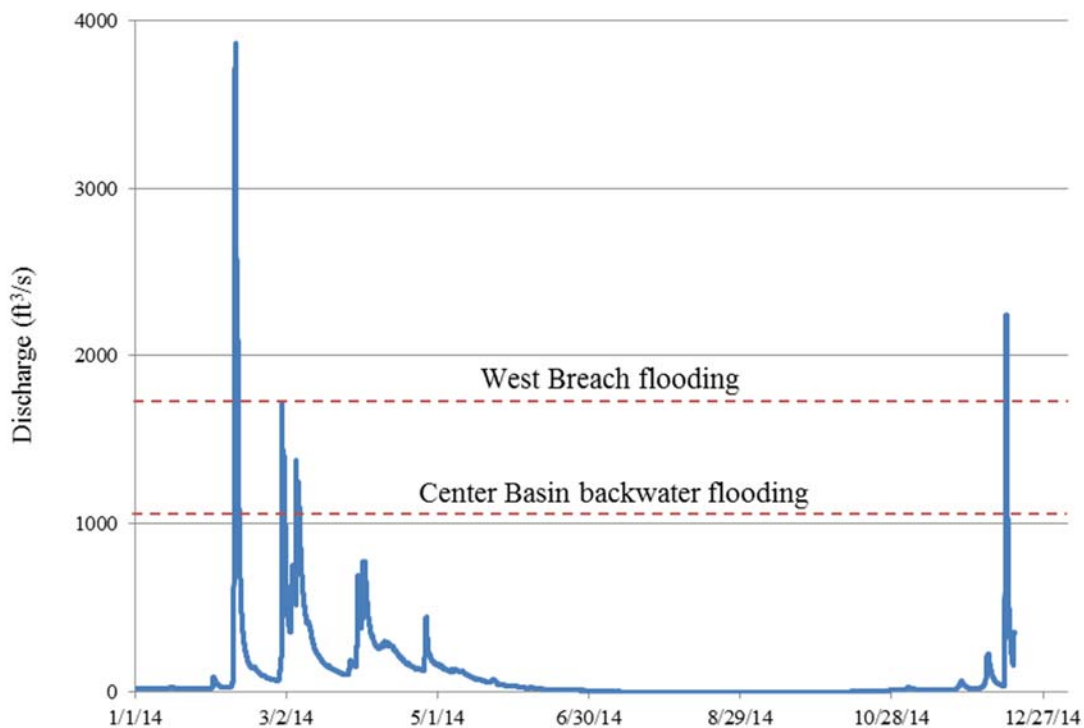
Figure 2. River hydrograph for the Cosumnes River at Michigan Bar from January 1, 2014 through December 14, 2014.

Due to statewide drought conditions, the Cosumnes River adjacent to the Oneto-Denier restoration site was dry until February 9, 2014. On this date, a large, regional precipitation event allowed for a rapid increase in streamflow magnitudes in the Cosumnes River to 3860 ft³/s (as measured by the United States Geological Survey at Michigan Bar; see Figure 2). The annual recurrence interval for this observed flow is approximately 1.4 years. In early March 2014, two ~1.2 year recurrence interval floods (~1,500 ft³/s) were observed in the Cosumnes River.

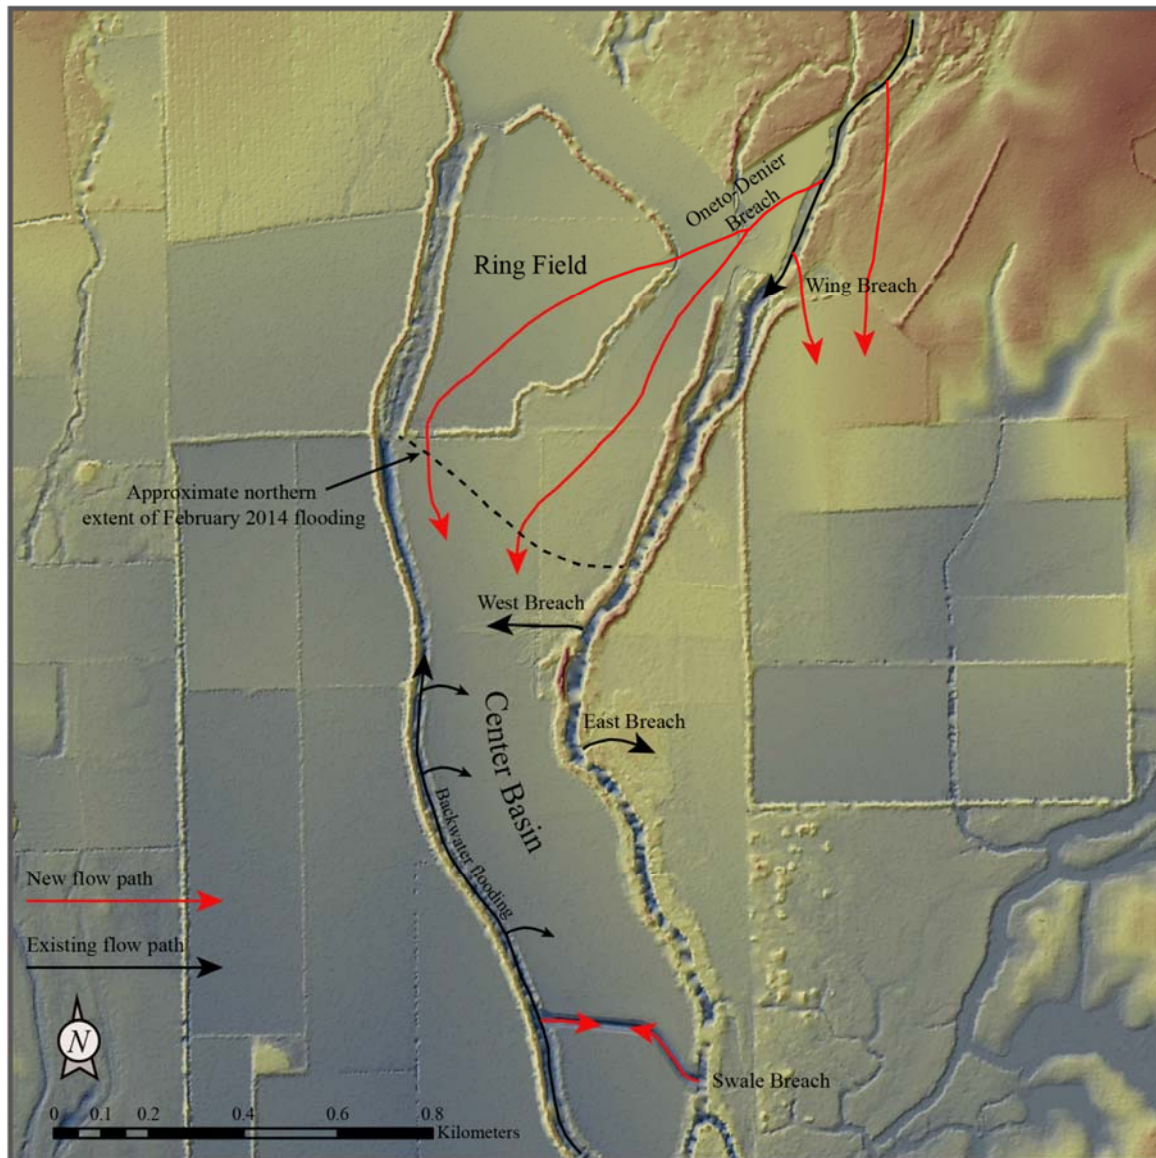
Figure 3. Oneto-Denier floodplain topographic conditions in Fall 2014 (following earthwork activities). Prominent levee breaches and flood flow paths are identified.

Observations during winter 2014 indicated that flooding of the Center Basin of the Oneto-Denier Restoration site (Figure 3) occurred during the February and March 2014 flood events. Floodwaters entered the Center Basin in two ways. During the February 2014 hydrologic event (peak flow of 3860 ft³/s), floodwaters entered the Center Basin through both the “West Breach” and as backwater flows from the small channel located along the western edge of the Center Basin. However, during the smaller magnitude March hydrologic events (<1700 ft³/s), flood flows did not enter the West Breach. As such, observed flooding only occurred in response to backwater flows in the western Center Basin channel. Backwater flooding appeared to initiate when flows in the Cosumnes River exceeded approximately 1000 ft³/s. Floodwaters were not observed in the Center Basin south of the Ring Field during the winter of 2014.

(DEM) of the project site (see Figure 3). This 1 m-resolution DEM will serve as the topographic baseline data set for the restoration project.

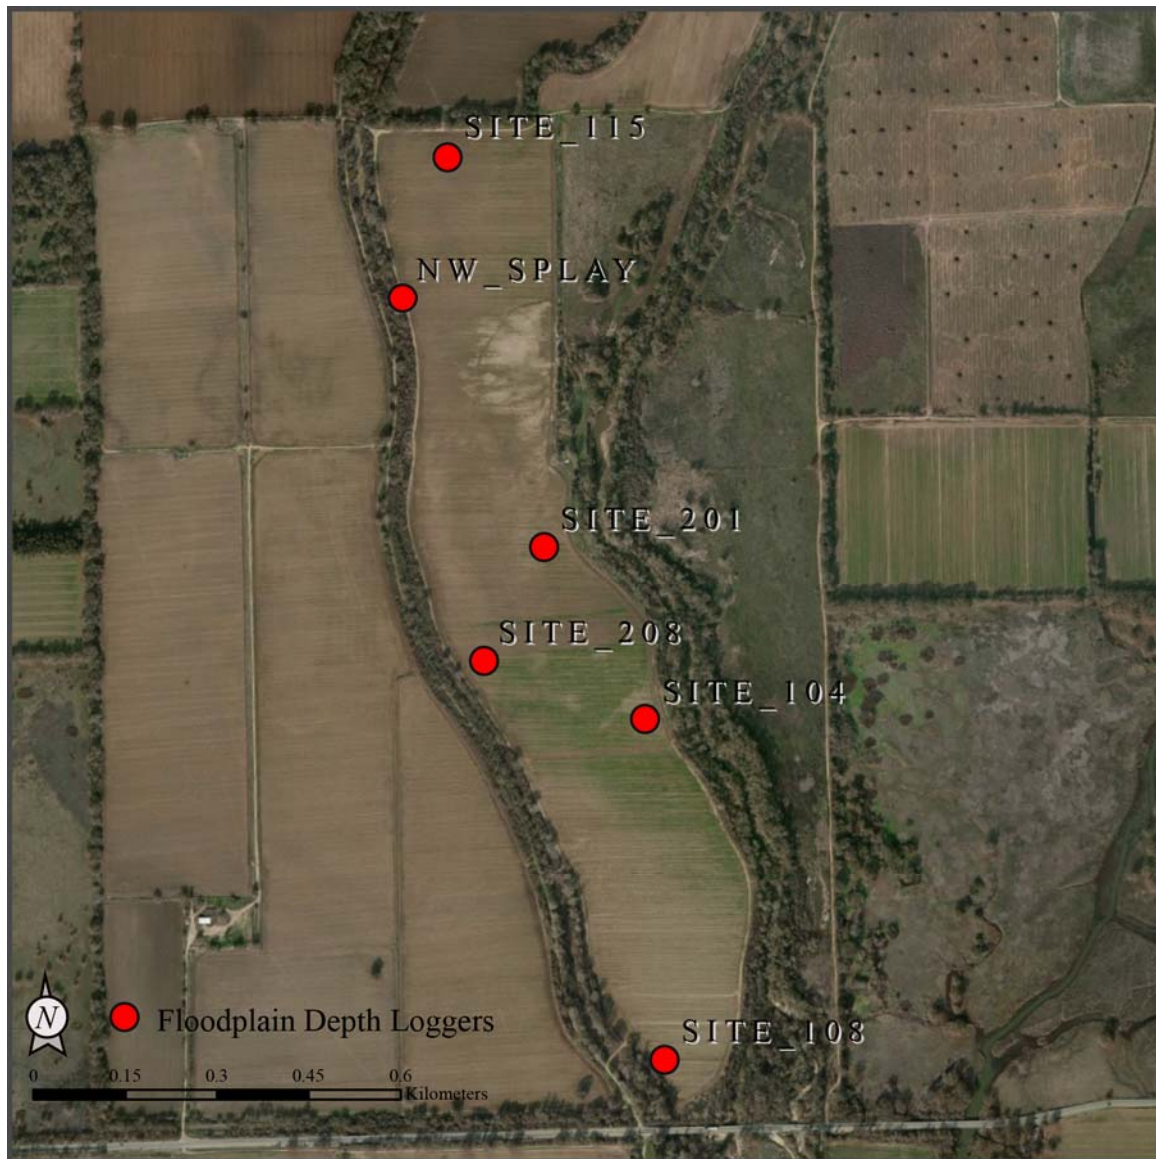
Figure 4. Floodplain depth loggers places in the Center Basin of the Oneto-Denier Restoration site in Winter/Spring 2014.

Floodwater characteristics were monitored throughout the Center Basin (Figure 4) in the Winter and Spring of 2014 to assess the spatial variability in floodwater timing, duration and depth. Due to existing

floodplain topography, flooding in the southern and western portions of the Center Basin was deeper, more frequent, and of longer duration. For example, during the February 2014 flood event, flooding was observed in the southwest corner of the Center Basin (Site 108) for approximately 78 hours, and flood depths exceeded 1m (Figure 5). However, at Site 104 along the eastern edge of the Center Basin, flooding during the same hydrologic event only lasted 30 hours, and maximum observed water depths were 0.22m (Figure 5). During the smaller magnitude floods in March 2014, only the southwestern portion of the Center Basin (Sites 108 and 208) were inundated with floodwaters (Figure 5). These observations identified considerable spatial variability in floodwater characteristics throughout the Center Basin, particularly during small floods (<2 year recurrence intervals).

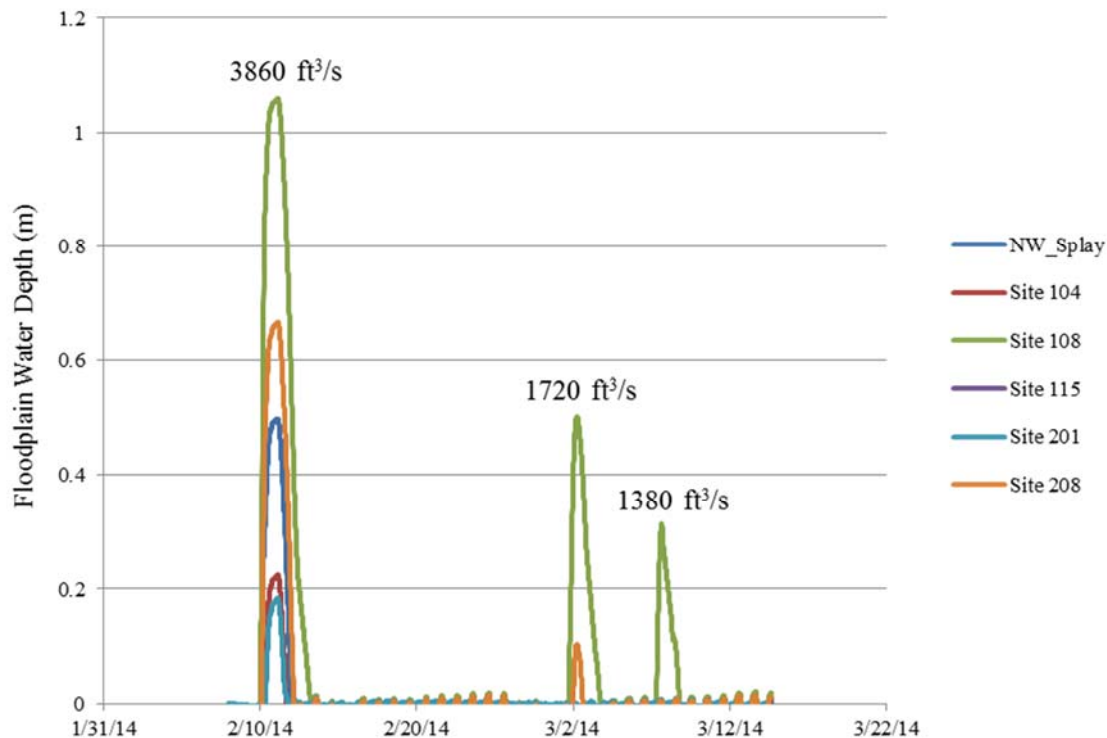
Figure 5. Timing, duration and depth of floodwaters in the Center Basin during February and March 2014. Maximum flow magnitudes during each flood event are presented.

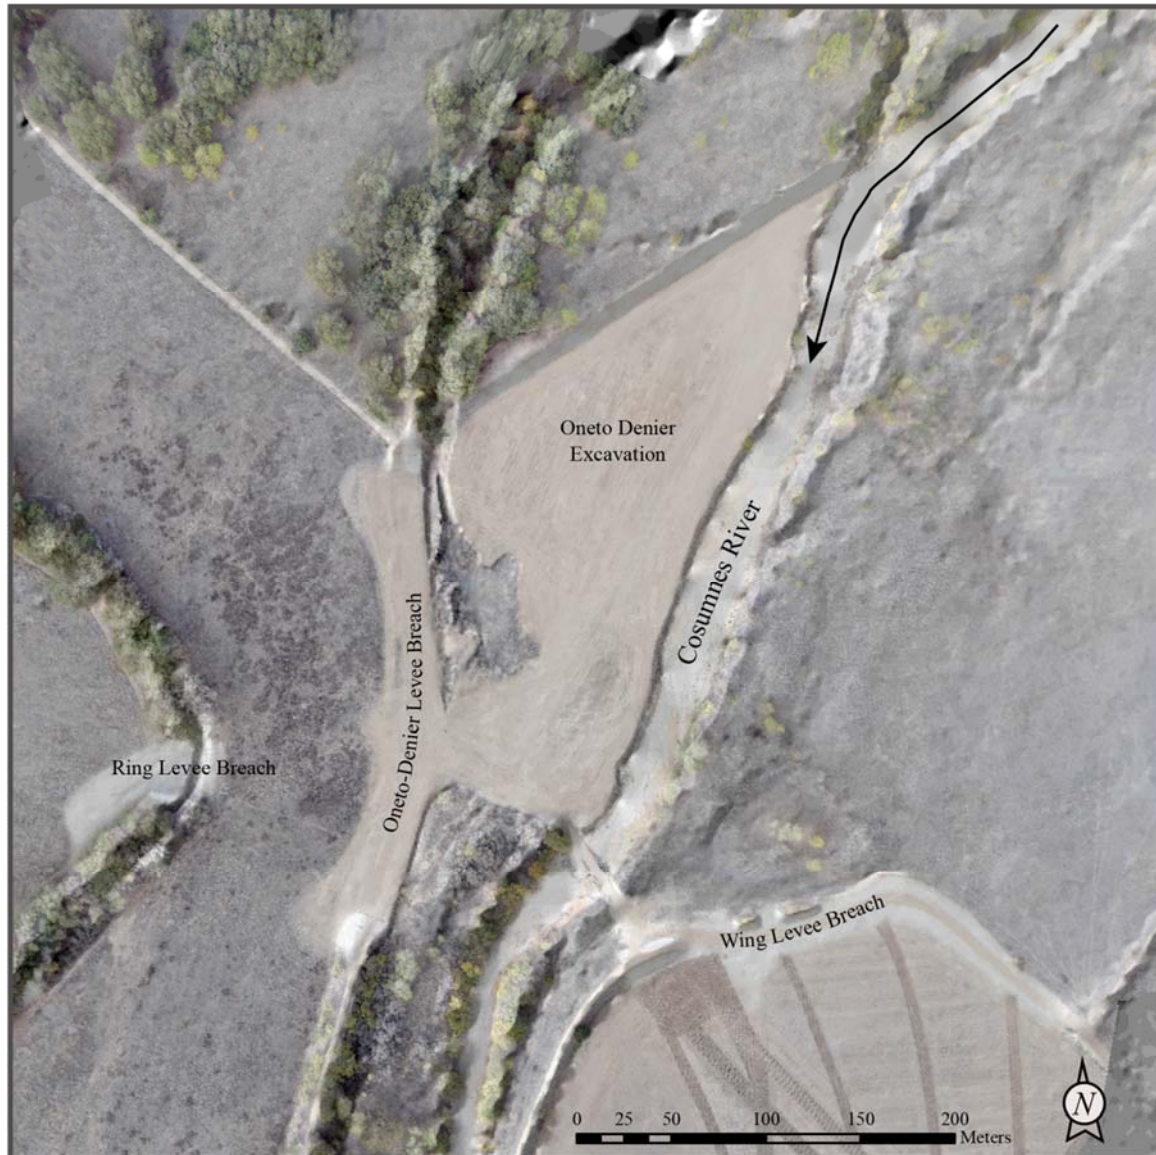
Figure 6. Oneto-Denier floodplain excavation and the Oneto-Denier Levee, Wing Levee and Ring Levee breach locations.

Detailed topographic surveys were conducted in levee breach and floodplain excavation areas throughout the Oneto Denier restoration site (e.g. Figure 6). Following earthwork activities, more than 20,000 topographic points were collected with a Realtime Kinematic (RTK) Global Positioning System (GPS) survey unit to document post-construction topographic conditions. Topographic data points collected with the RTK survey unit were integrated with an existing topographic data set [Central Valley Floodplain Evaluation and Delineation Program (CVFED) LiDAR] to create a Digital Elevation Model

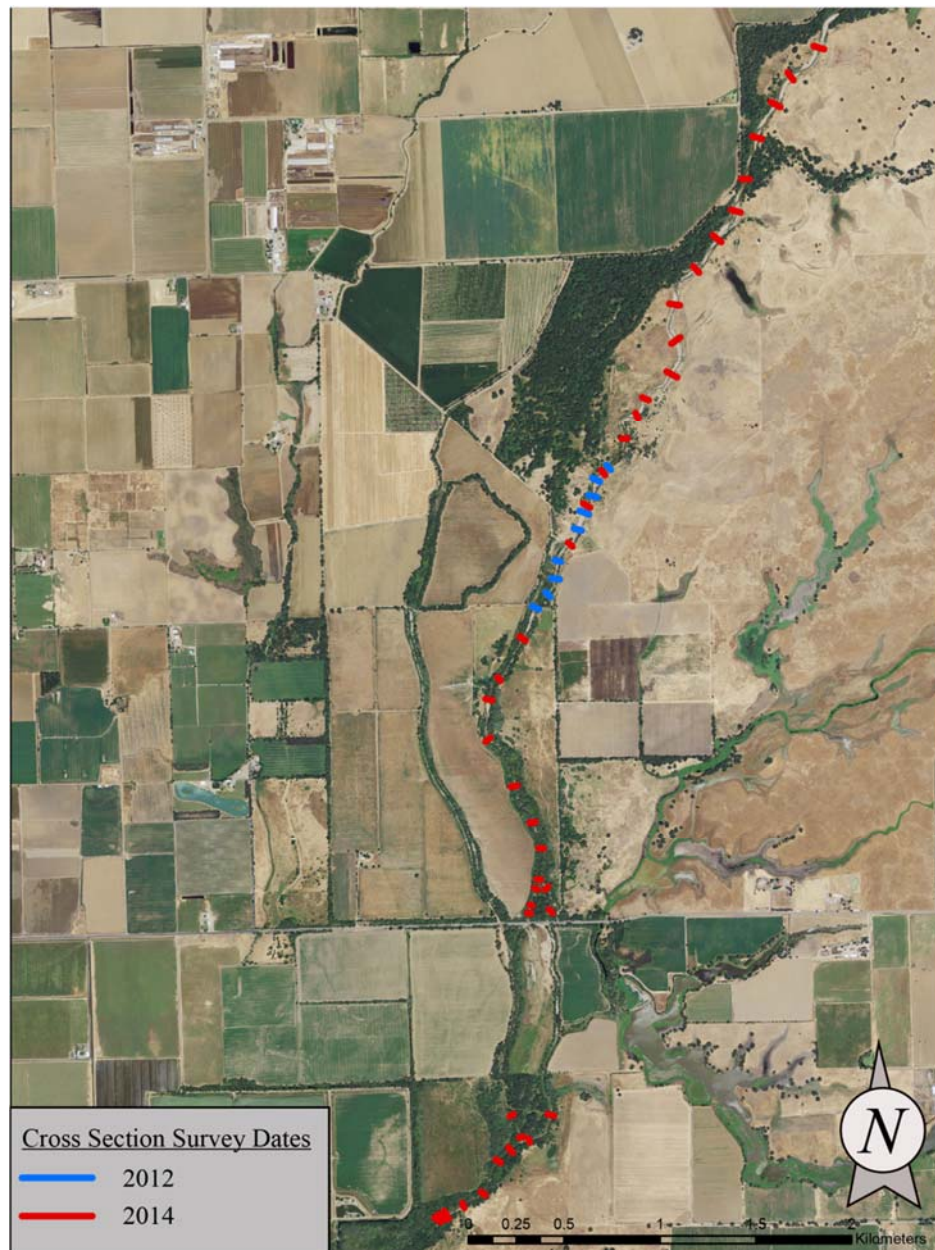
Figure 7. Channel cross sections surveyed in 2012 and 2014.

During Summer 2014, river channel cross-sections were surveyed at regular intervals along the channel reach extending from approximately 1km upstream of Badger Creek to the “Triangle Floodplain” restoration site (Figure 7). Surveyed cross sections extended onto the floodplain banks, and documented major topographic breakpoints, including the bank edges, toes and channel thalweg. These data will be used to characterize baseline geomorphic conditions prior to levee breaching activities, and to support hydrodynamic modelling efforts of the CRG3 research group.

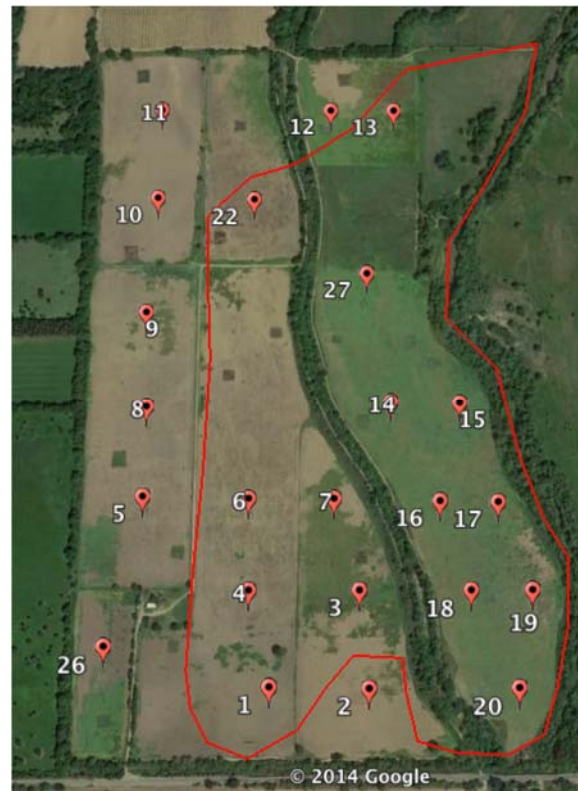
Figure 9. Map showing the soil sites that contain a buried horizon.

horizons. A significant difference was found between the C content of the surface horizons (0-1 ft) and deep horizons with low C contents (Figure 9 and Table 2) but not between the surface and buried deep horizons with high C contents. This result indicated that the soils categorized as having a 'buried' horizon do in fact have a buried horizon. A buried horizon is defined as a surface horizon that becomes buried due to a depositional even, such as a flood. This event halts further soil forming processes to occur. Buried horizons have higher C contents than expected for horizons at their depth. Because there is no significant difference between the C content of the deep and surface horizons for the soils categorized as buried, it can be inferred that these deep horizons are buried horizons. The statistical analysis verified this approach where non-buried horizons had statistically significantly lower C contents than the surface horizon (0-1 ft).

would support our original hypothesis that soil C is sequestered on floodplains. It is very possible that soils from boreholes 11, 10, 9, 8, 5 and 26 above represent the historical channel of the Cosumnes River seen in maps from the 1850s. Soil textural data is a key component to further analyzing these geomorphic connections. In the coming month, this connection will be explored further by measuring particle size distribution using the hydrometer method.

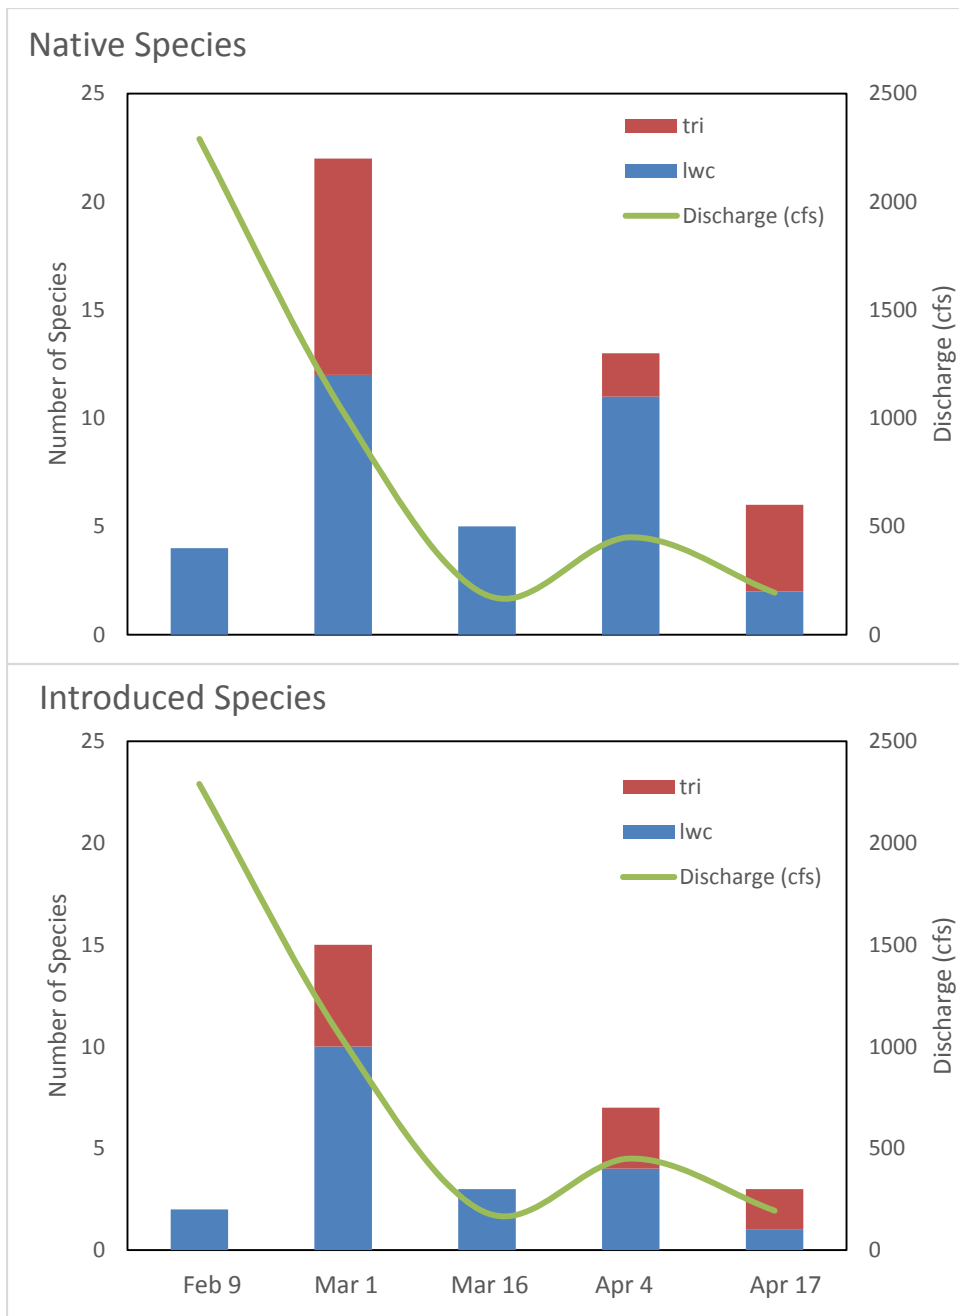
Figure 10. Instream hydrochory species counts (diversity) by sampling date for native and non-native species at the Low Water Crossing and the Triangle. Discharge (cfs) at the Michigan Bar gage is displayed on the secondary Y-axis.

We recorded 33 distinct species, 19 of which were native and 14 of which were non-native that germinated in the greenhouse (Figure 10) from samples collected at the Low Water Crossing and Triangle floodplain. Instream samples that contained the greatest number of species and the greatest number of germinating material coincided with the 3/1/14 small flood event.
